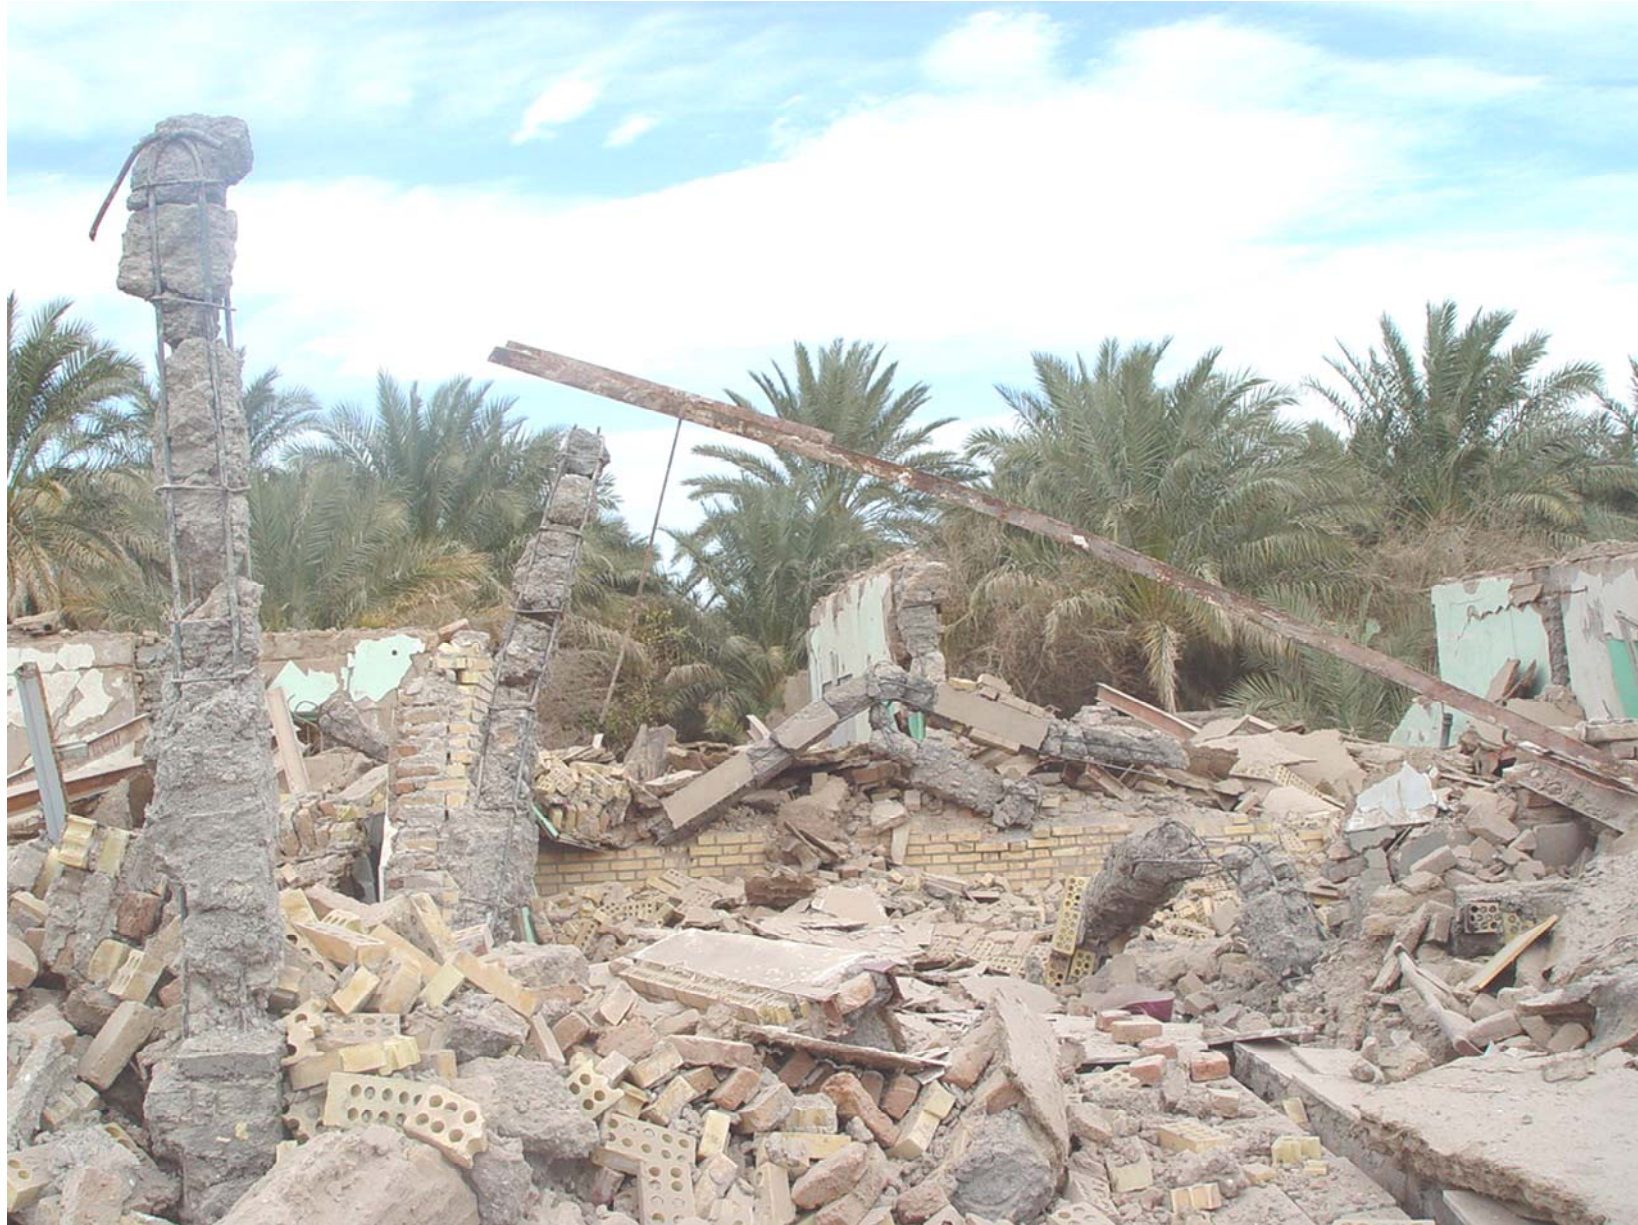
View of a confined brick masonry school that collapsed completely because of its poor construction quality and lack of proper detailing.

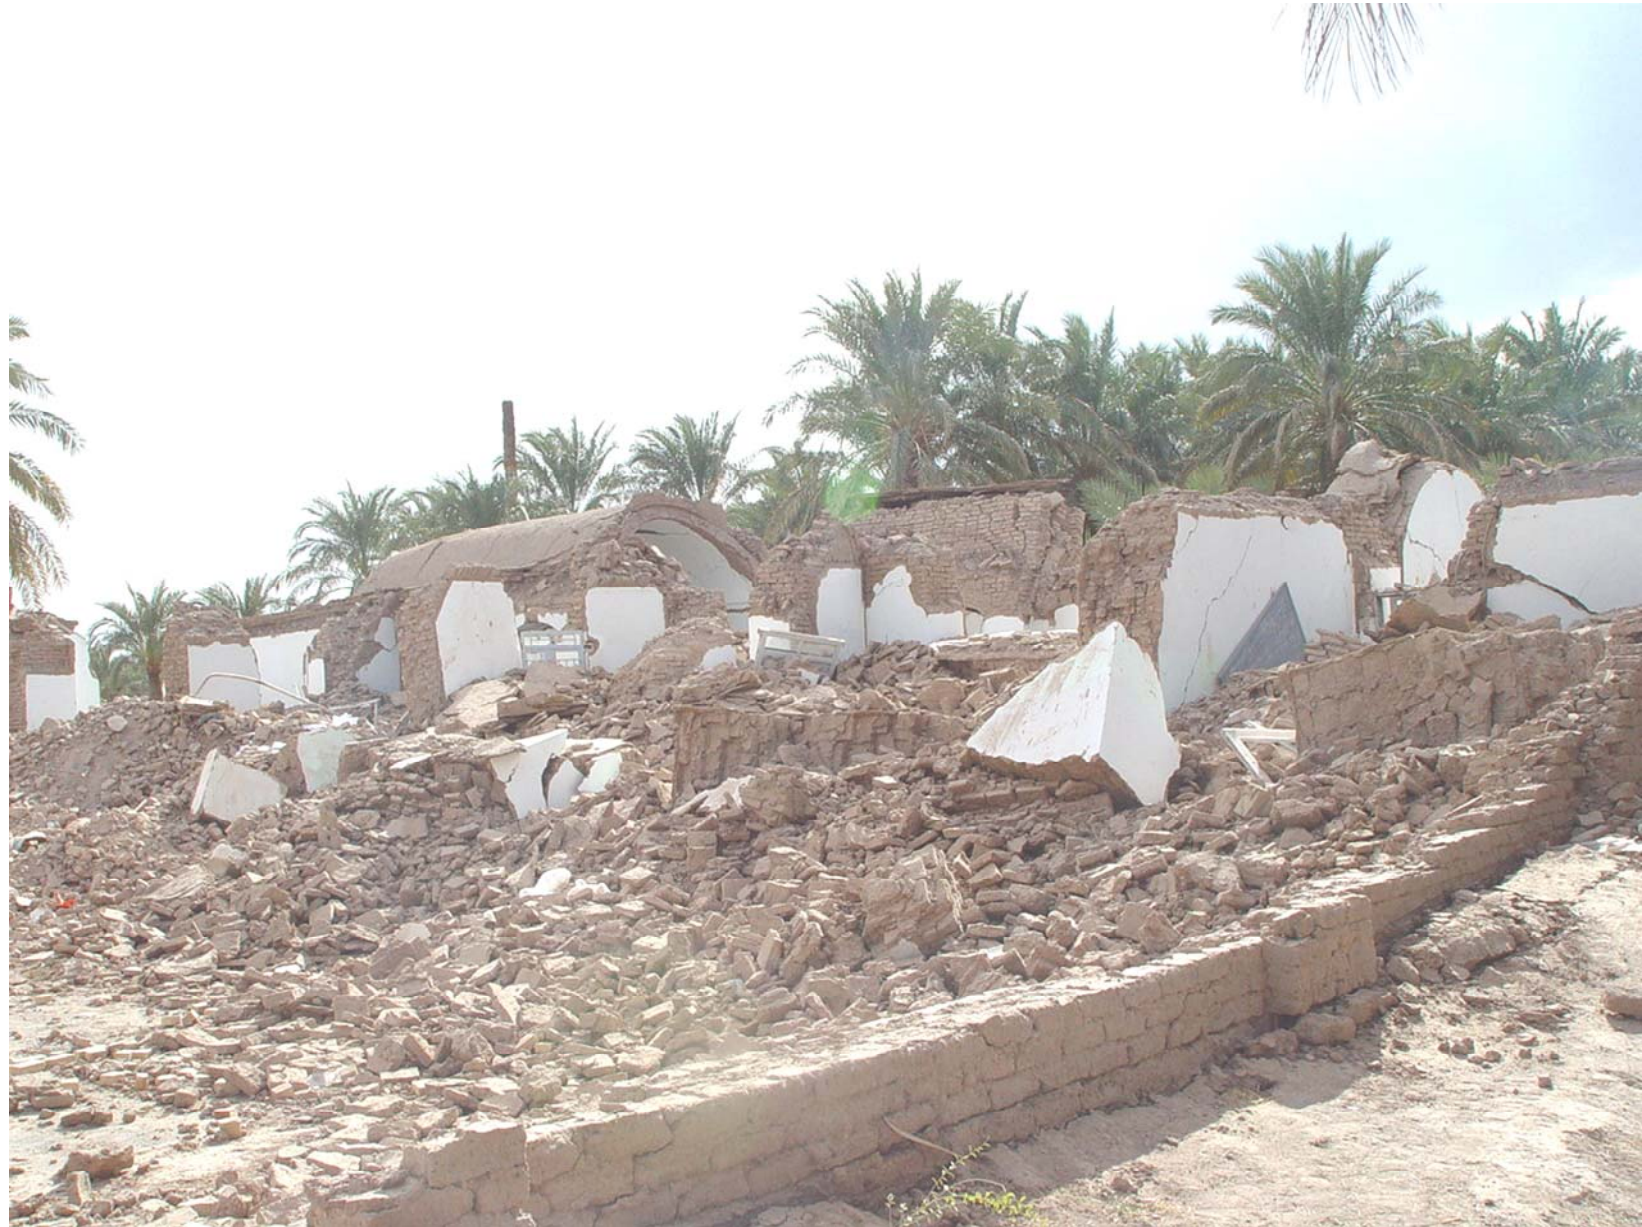
View of an adobe school that was completely destroyed.

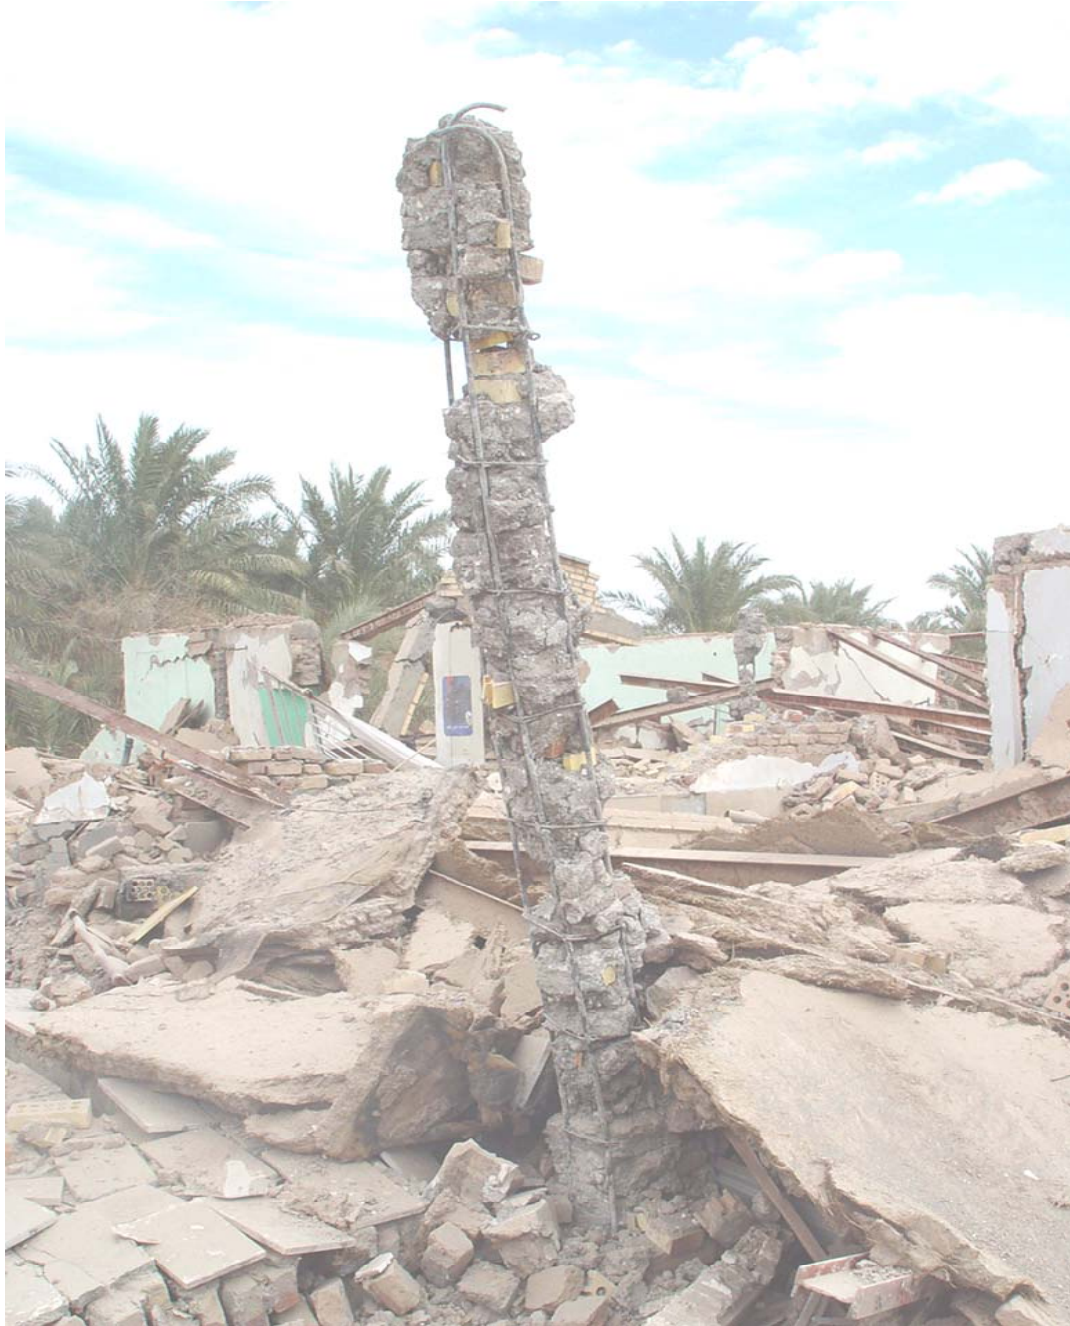
Mixing of concrete and brick in vertical ties.

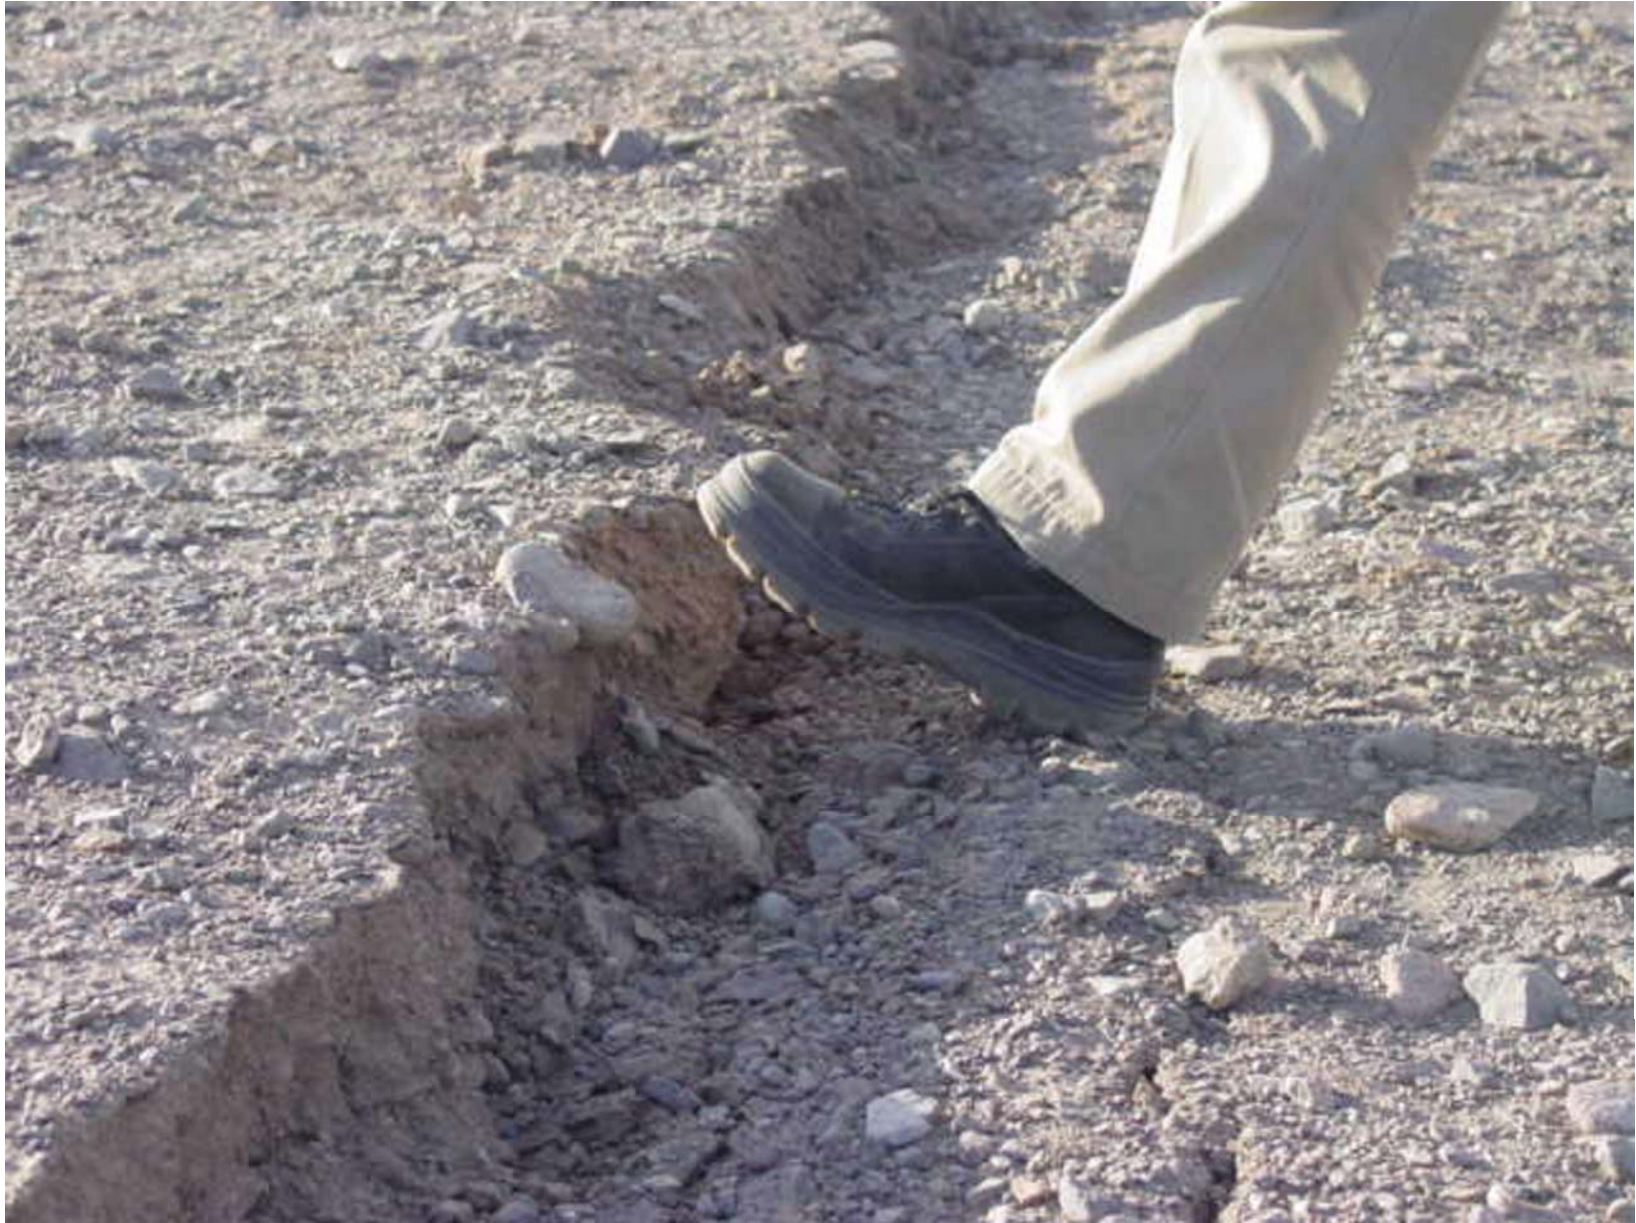
Settlement of earth fill surrounding the tank.

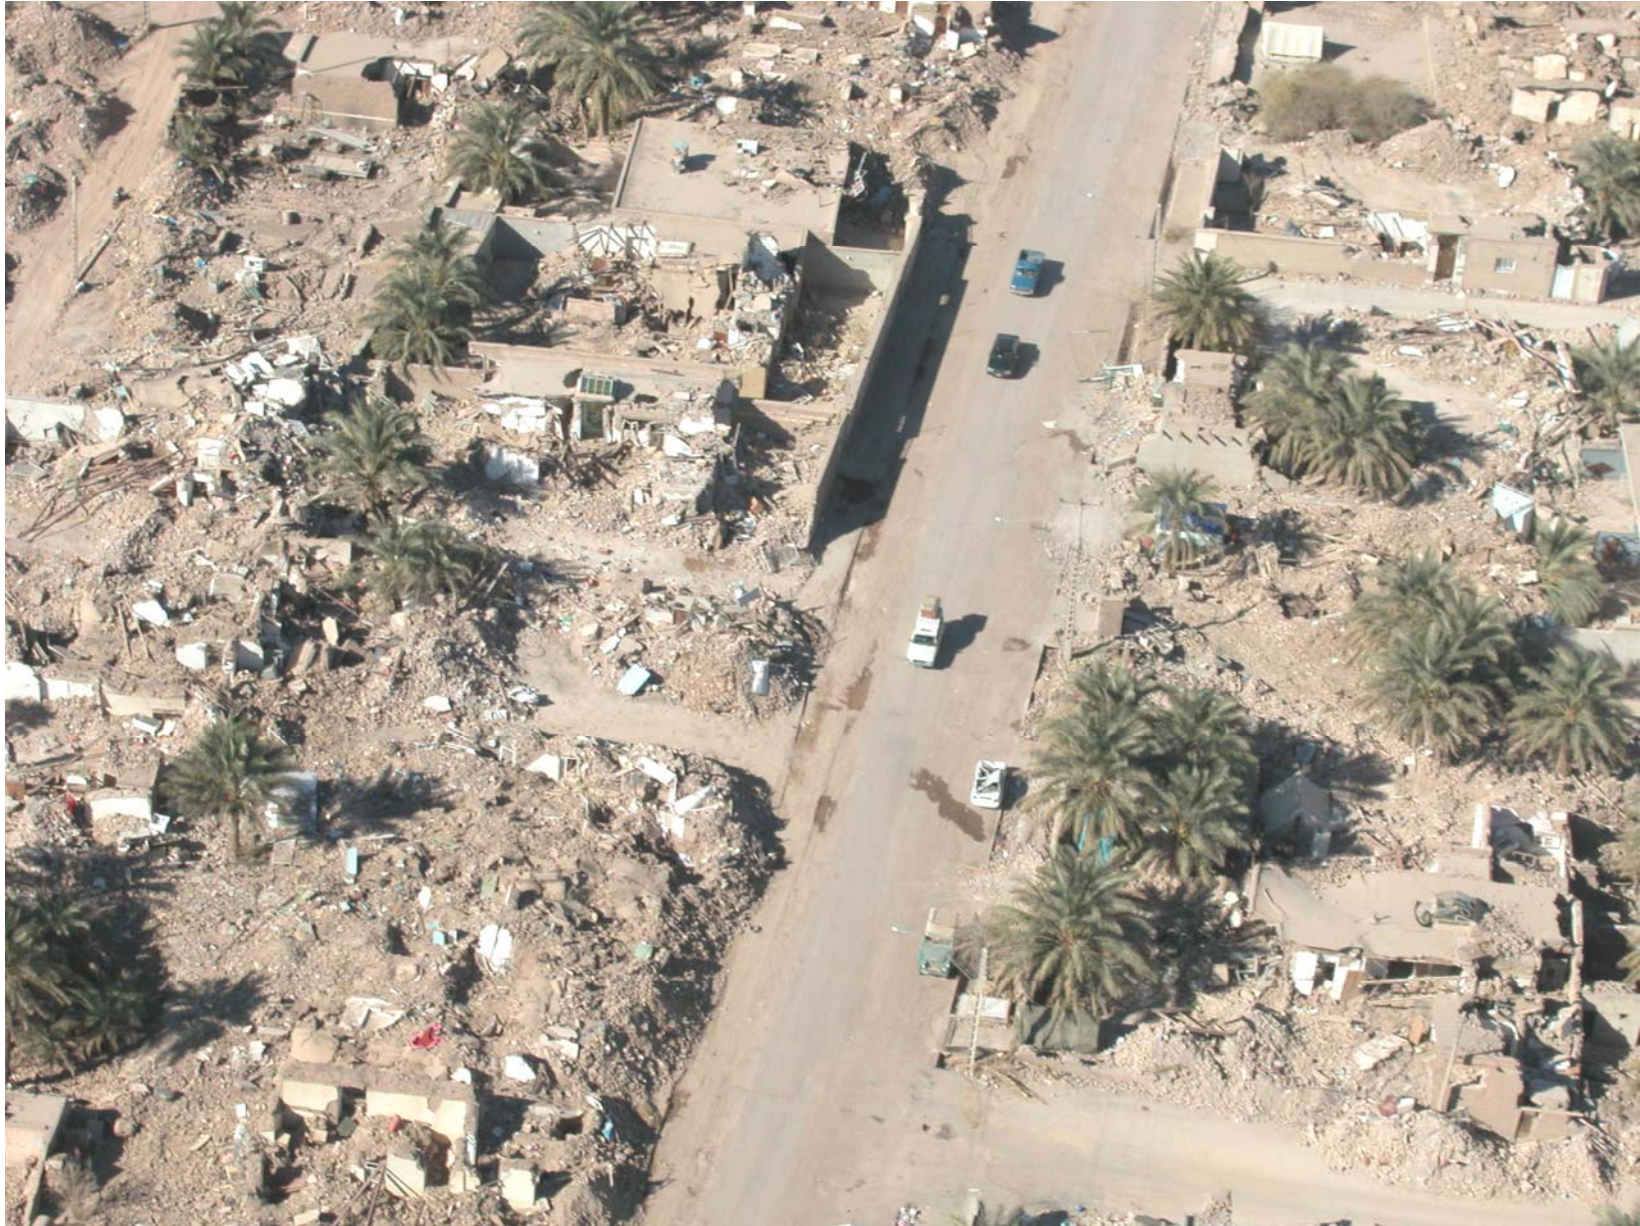
Aerial view of complete destruction of adobe dwellings the Bam earthquake.

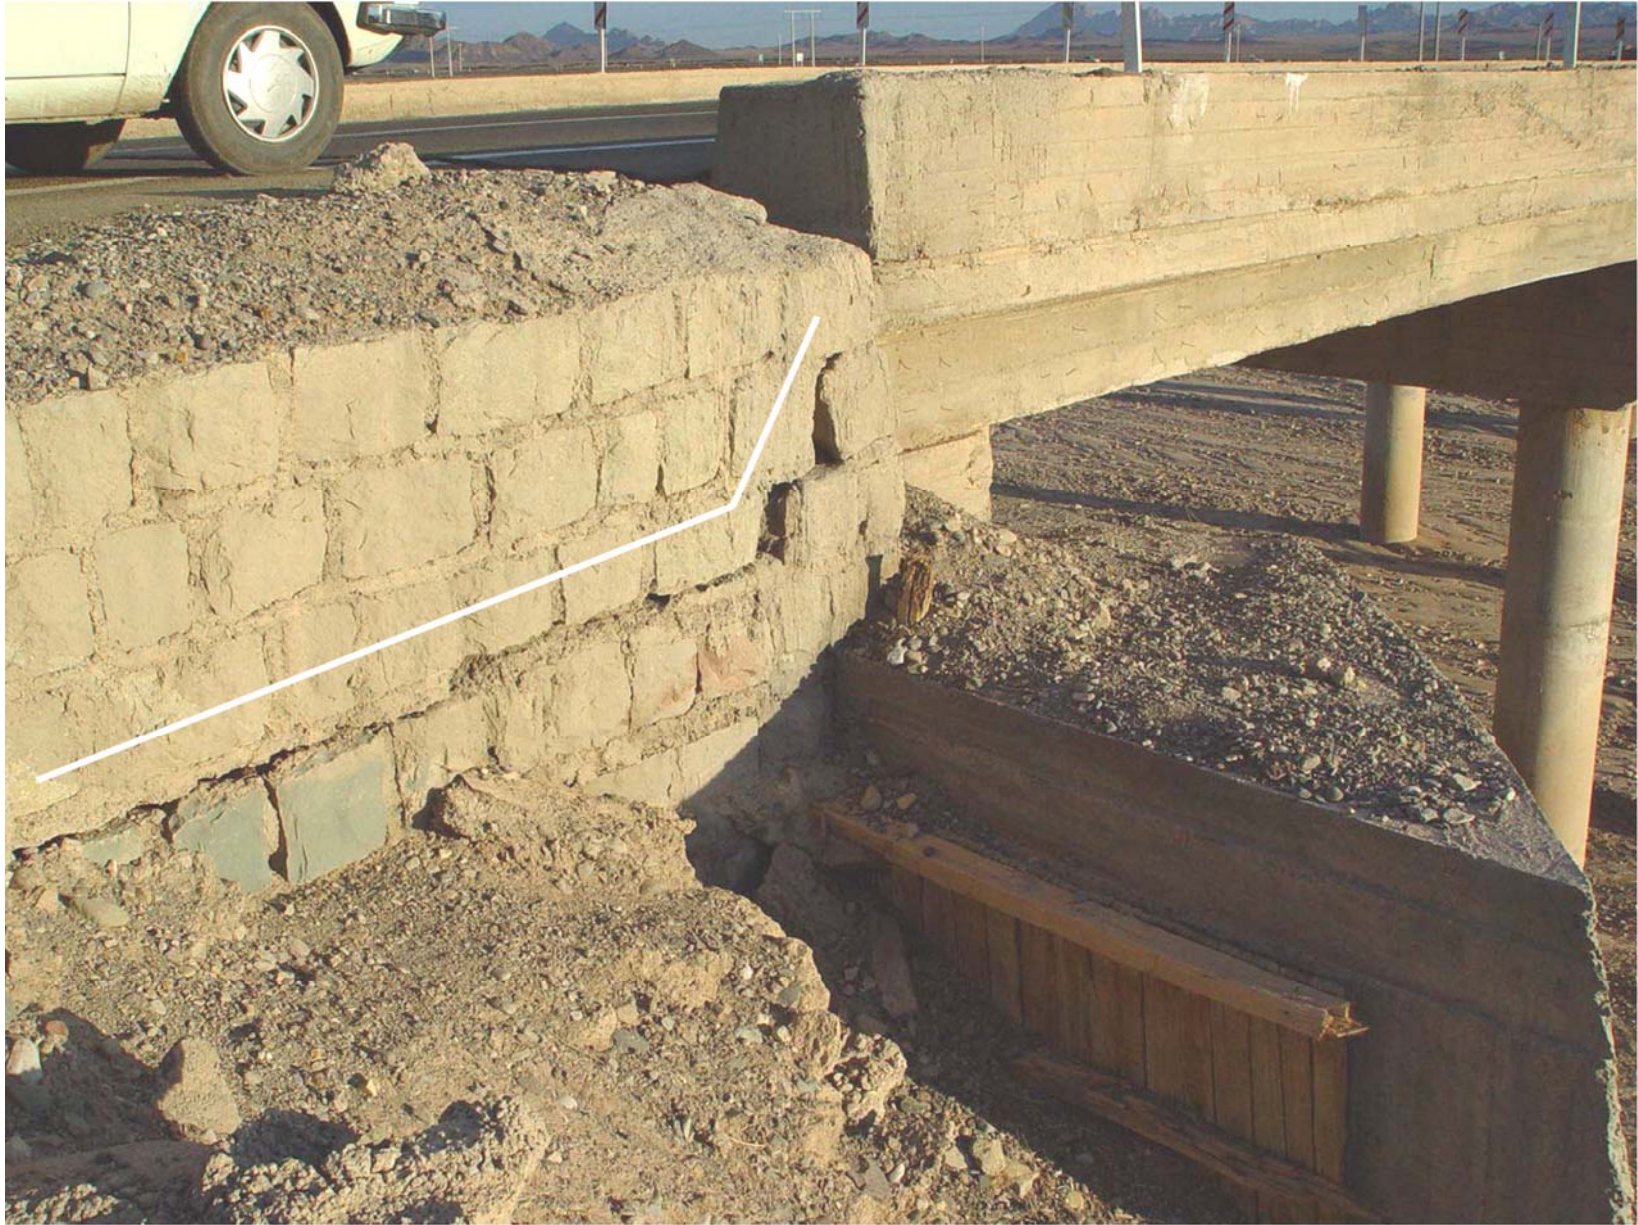
Settlement of abutment's backfill of Drazin Bridge.

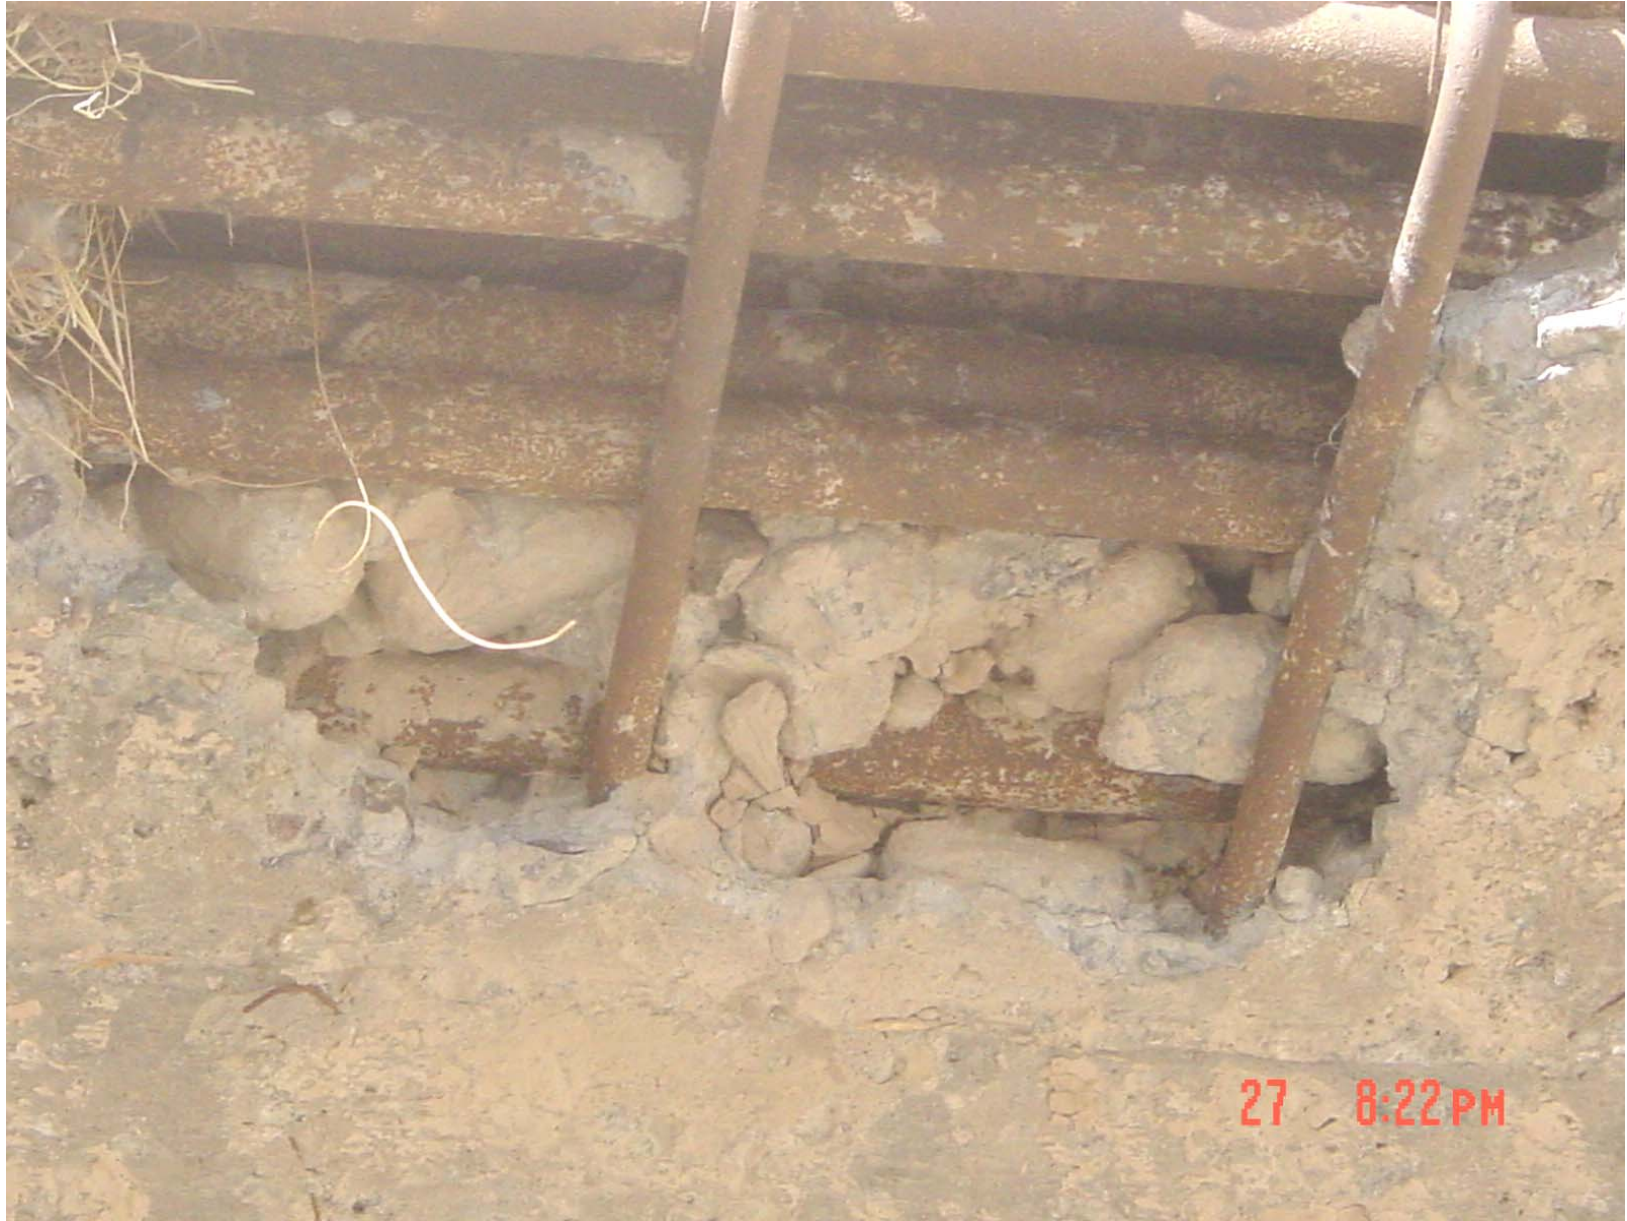
Inadequate concrete cover of beams.
