DAMAGE TO 9-STORY PRECAST CONCRETE FRAME BUILDINGS IN LENINAKAN

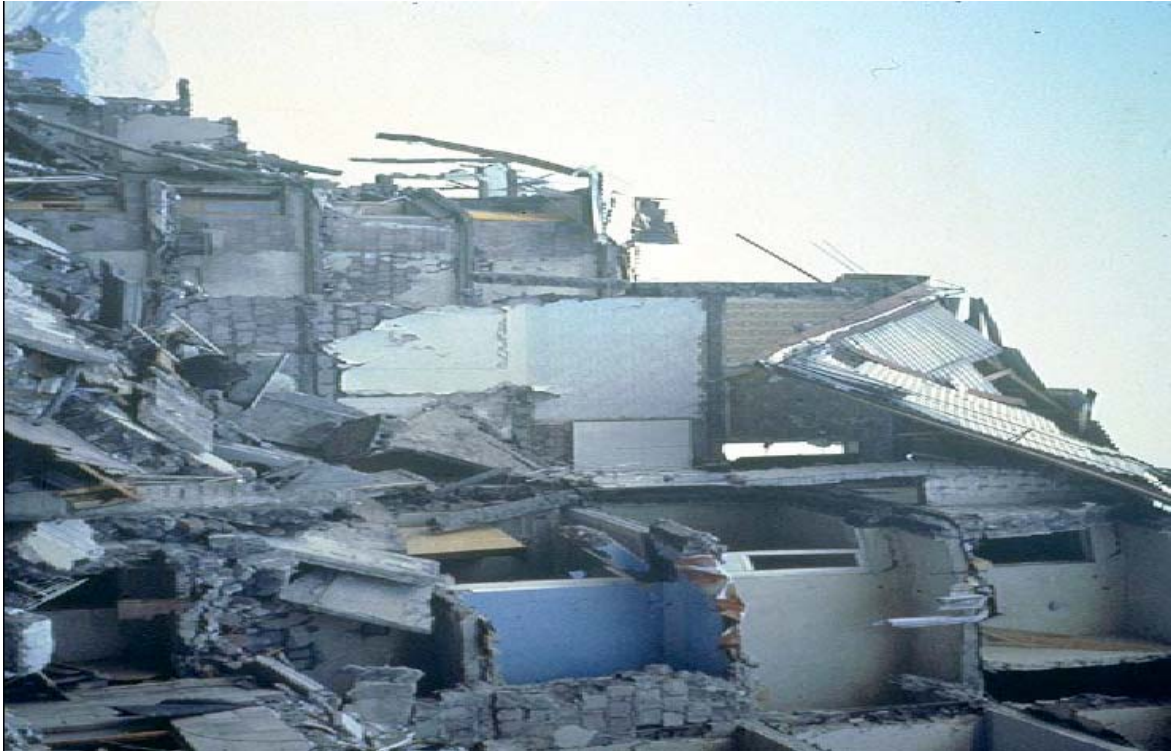
Collapsed and damaged nine-story precast concrete frame buildings in Leninakan. Poor diaphragm action due to lack of connections between the floor planks (flexicore precast floor panels) contributed to the failures.

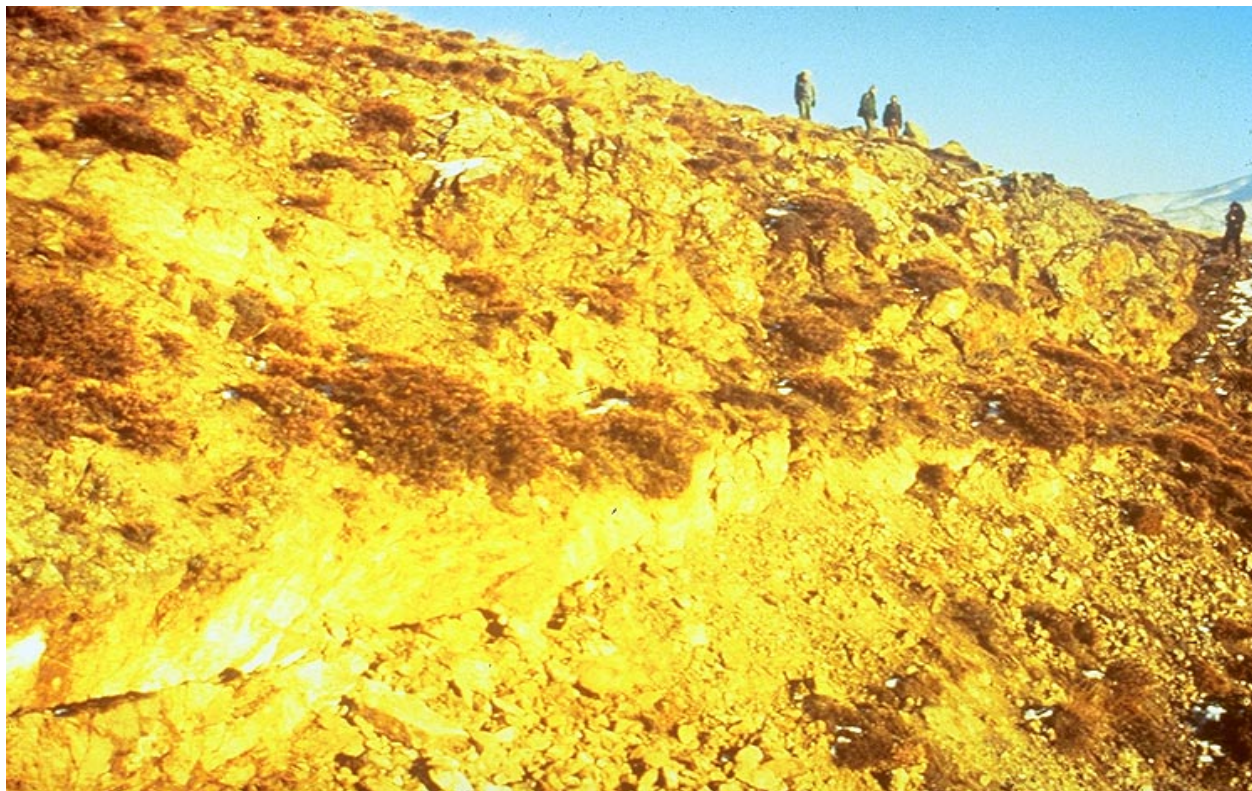
SURFACE FAULT RUPTURE

The vertical displacement of the upthrown block was 1-1/2 m, typical of a $M = 6.8$ earthquake. The fault broke the surface over 15 km and is assumed to be the causative fault. Professor Millernovsky (USSR) had mapped the fault 30 years earlier.

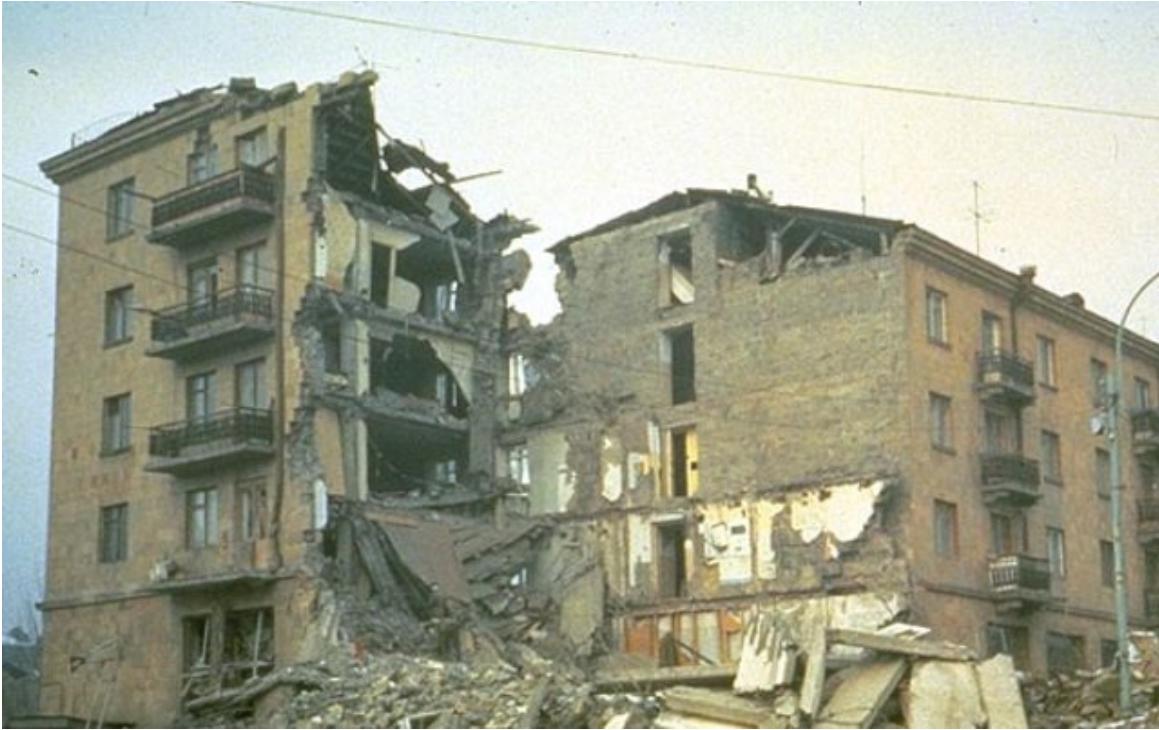
FAILURE MECHANISMS OF STONE-BEARING-WALL BUILDINGS
Shows the failure of the stone bearing wall systems at the corners where the two walls meet.

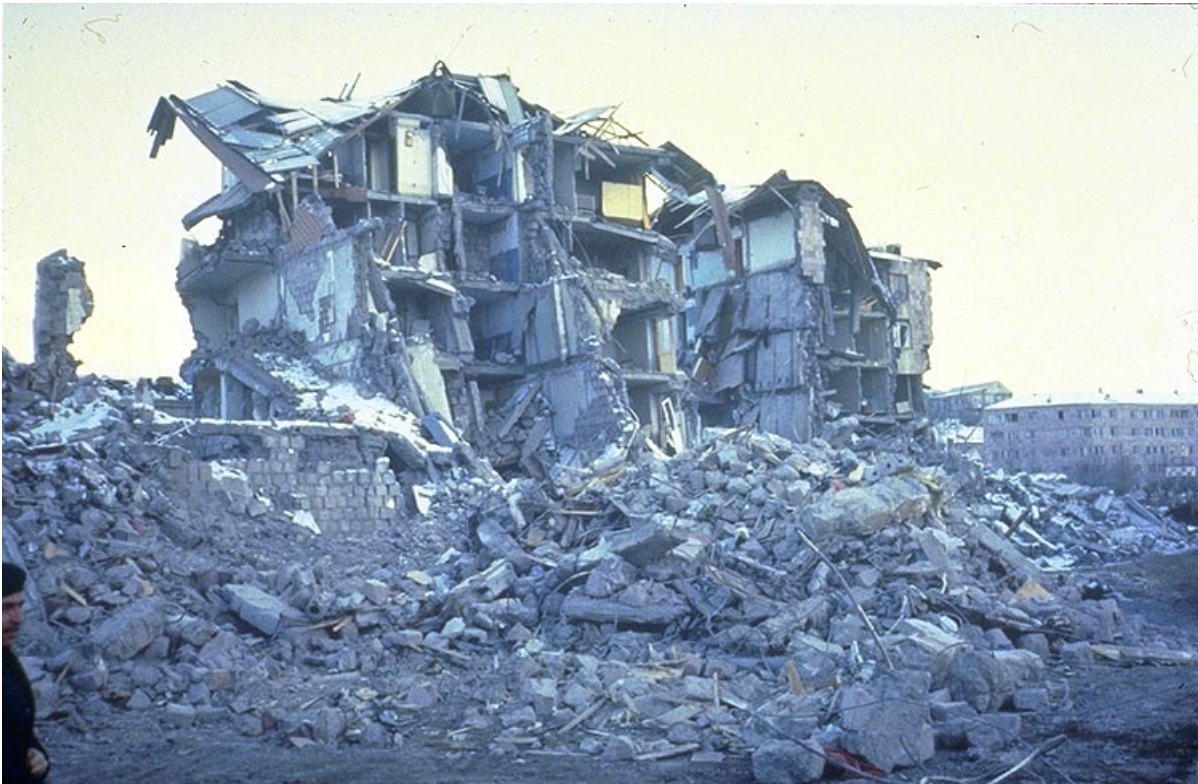
FAILURE MECHANISMS OF STONE-BEARING-WALL BUILDINGS
Shows damage to a stone bearing wall building in Leninakan. The floor planks were not tied to the supporting bearing walls.

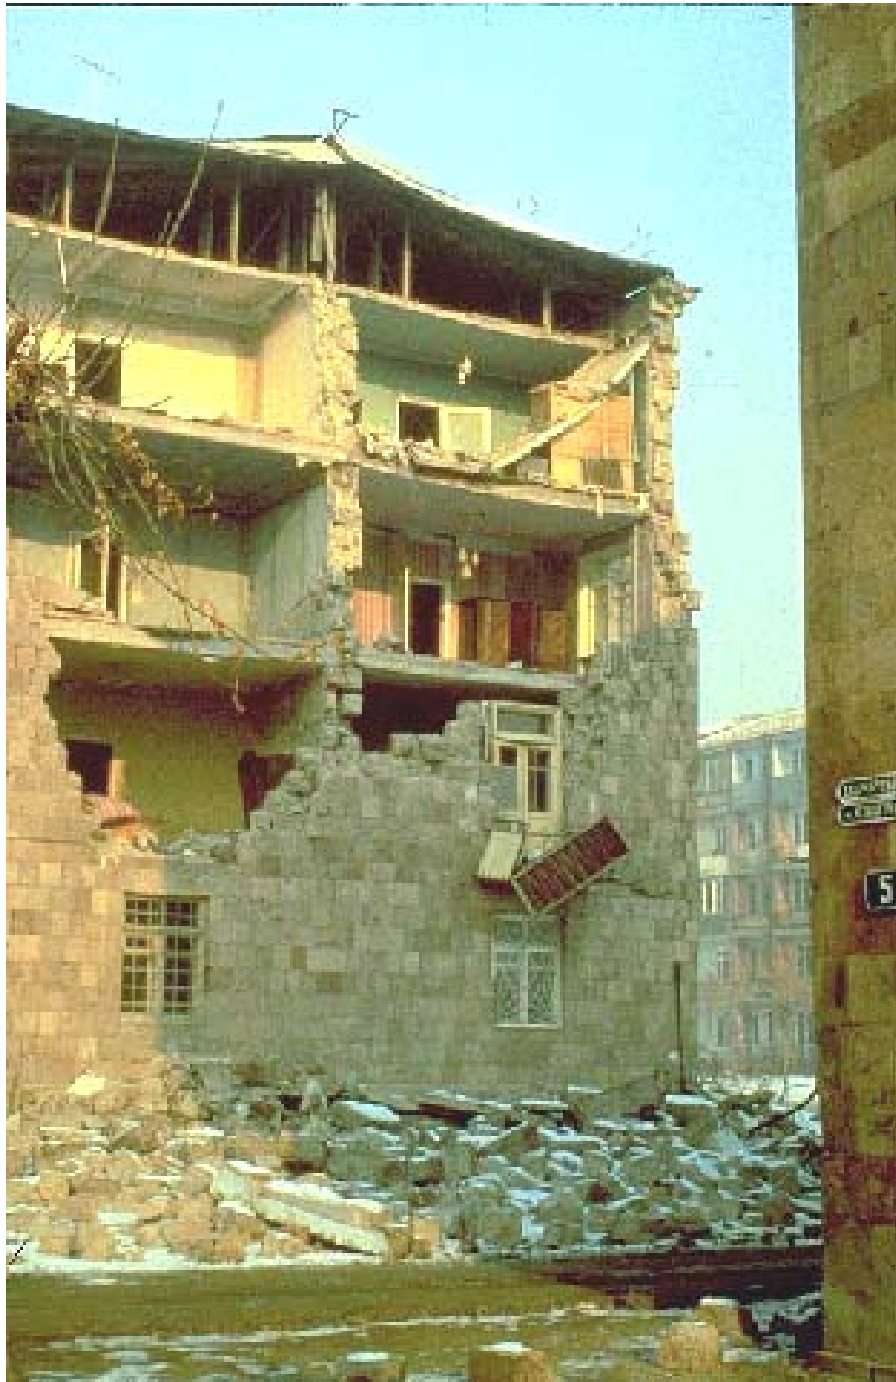
FAILURE MECHANISMS OF STONE-BEARING-WALL BUILDINGS

Shows the failure of a typical 4-story stone bearing wall building in Leninakan. The failure has exposed both the exterior and interior walls, revealing the method of construction of the walls as well as the flooring system. The floor is of light weight concrete planks with simple, narrow supports on the walls. Note that the floor planks at the fourth level have also fallen.

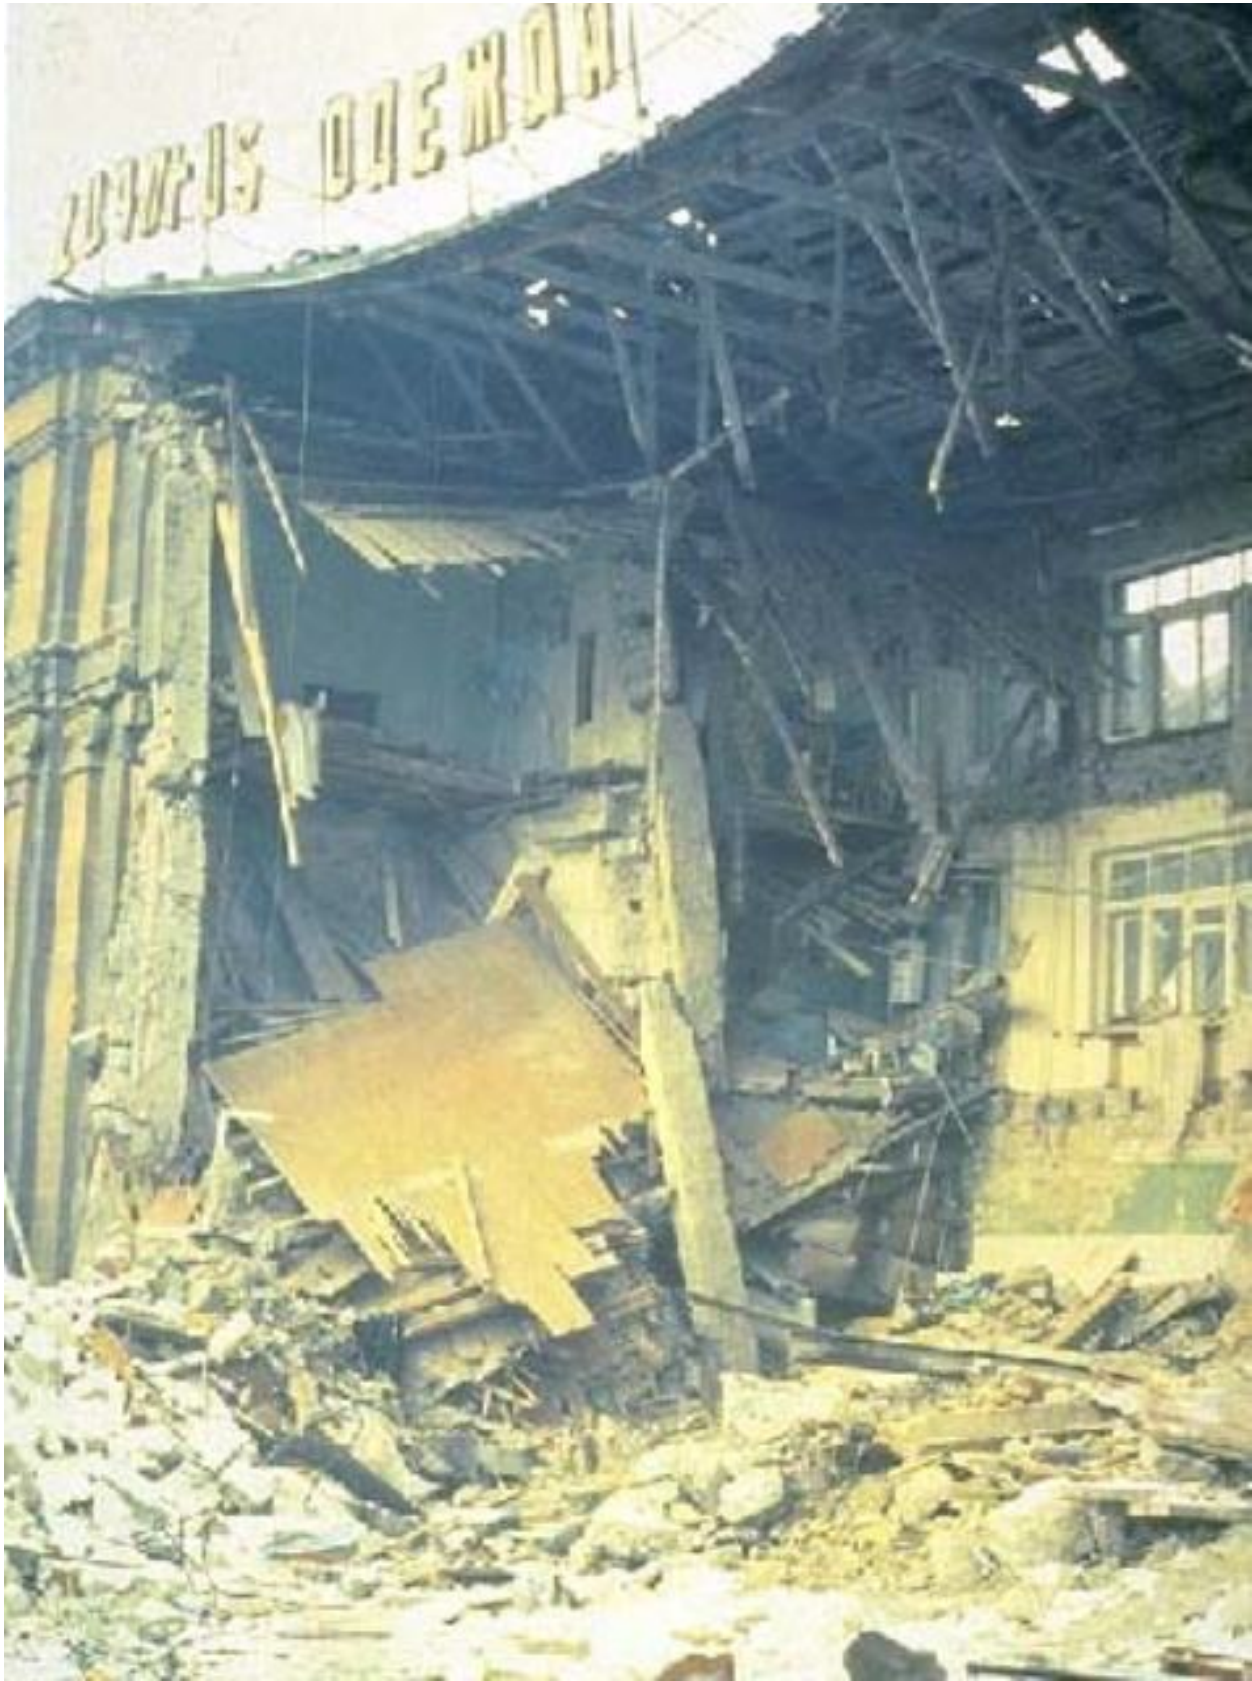
FAILURE MECHANISMS OF STONE-BEARING-WALL BUILDINGS

Shows damage to an old stone bearing wall building in Leninakan which was a hat and glove factory.

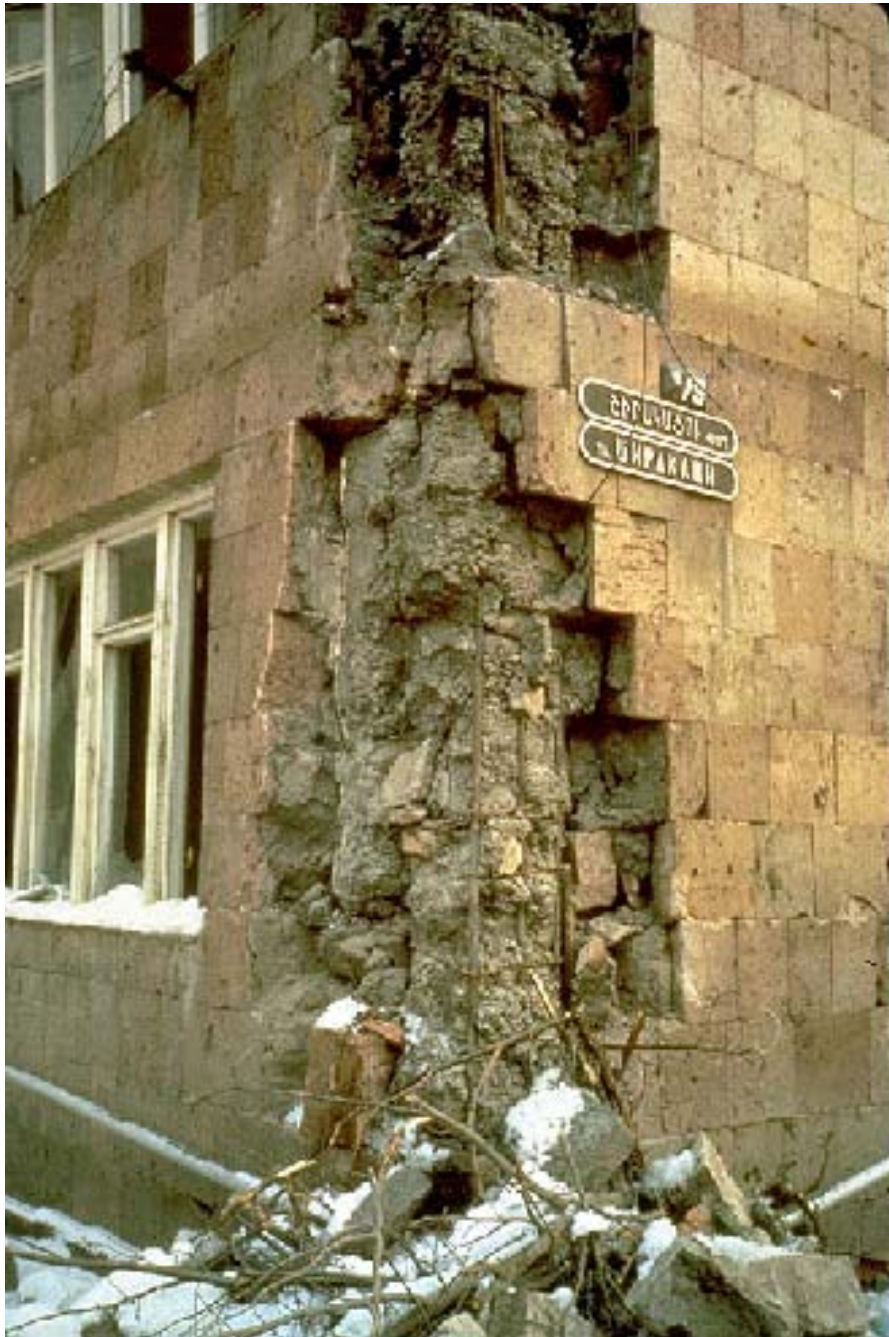
CORNER REINFORCEMENT OF STONE WALLS IN LENINAKAN

In their newer stone bearing wall buildings, Soviet engineers built a reinforced concrete member at the corner that provides continuity to both walls along the edges. In this slide, failure of the stone wall appears to have been arrested by this member. There were many cases, however, where this member many not have helped to stop the failure at the corner. Further study is required to evaluate the beneficial effects of this system.

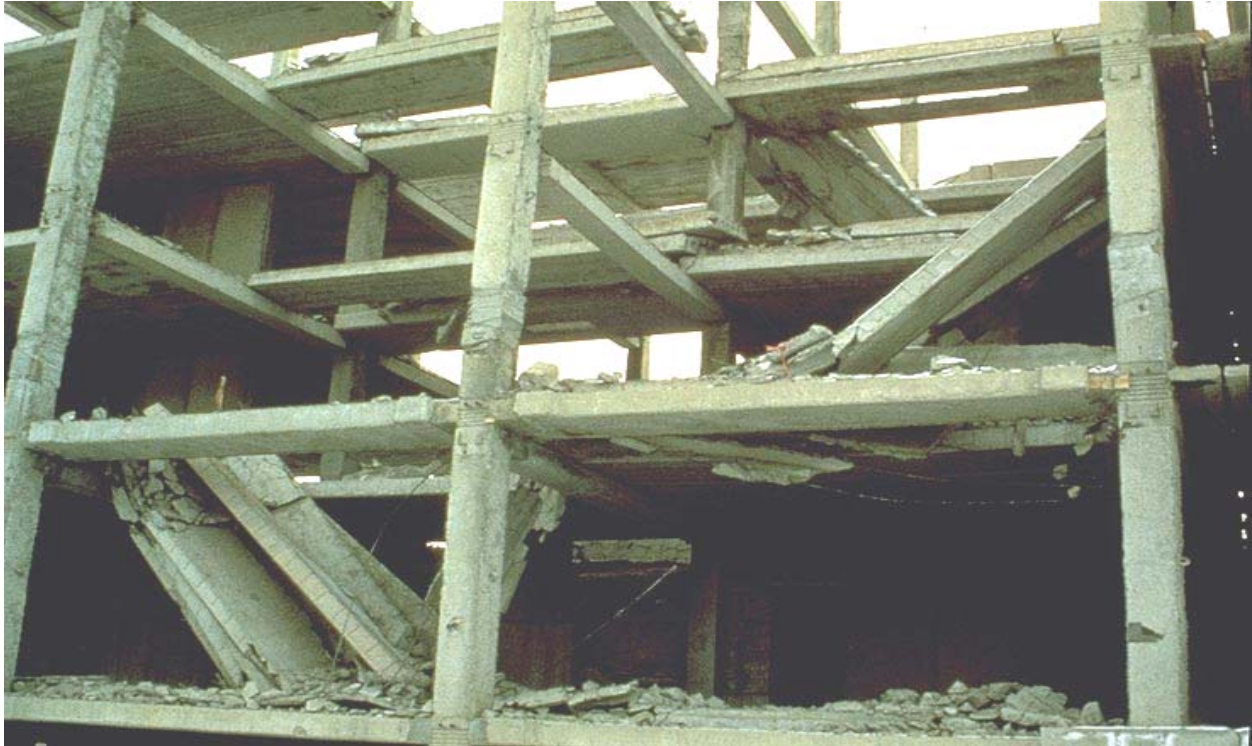
FAILURE MECHANISMS OF PRECAST CONCRETE FRAME-PANEL BUILDINGS

Shows the failure of floor planks of a building under construction which was to become the new building of the Polytechnic Institute. The floor planks, of lightweight concrete, hollow- core, and approximately 4 ft x 6 ft x 8 inches are simply supported on the beams over a 2 to 3 inch seat. There are no ties between the planks or between the planks and the beam reinforcement.

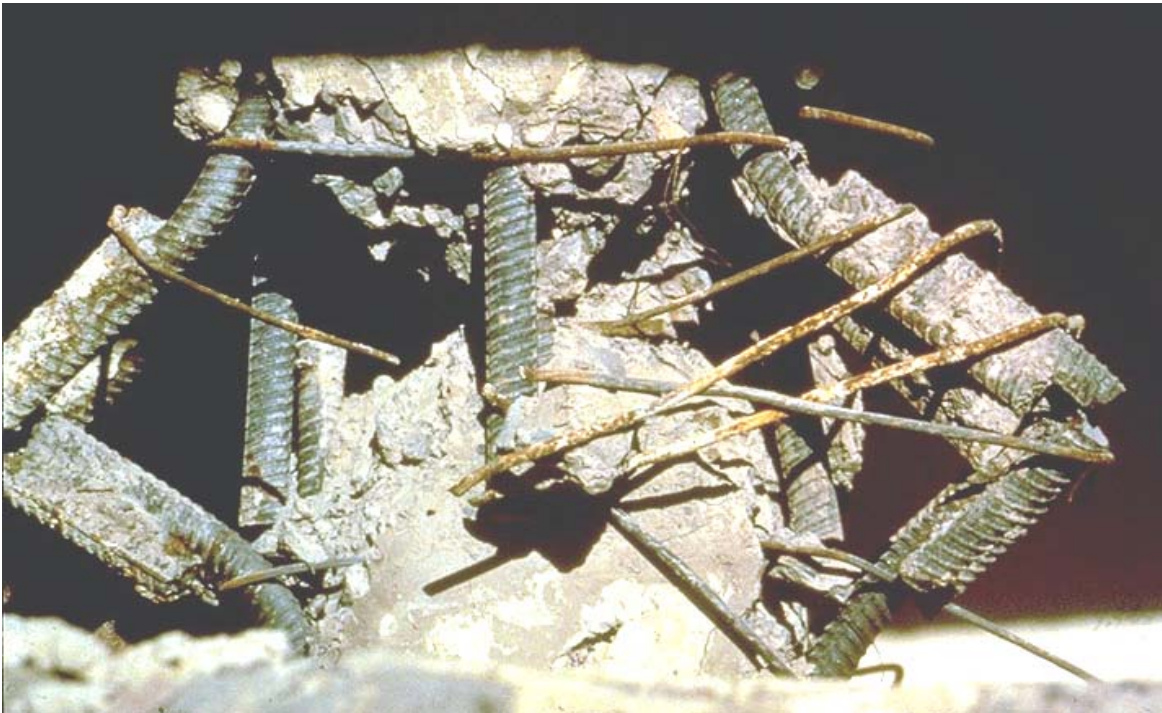
FAILURE MECHANISMS OF PRECAST CONCRETE FRAME-PANEL BUILDINGS

Brittle failure of welded rebars can be observed. Some rebars from the column above are not contained in the column below. This kind of failure at the connection between the precast column elements was very common.

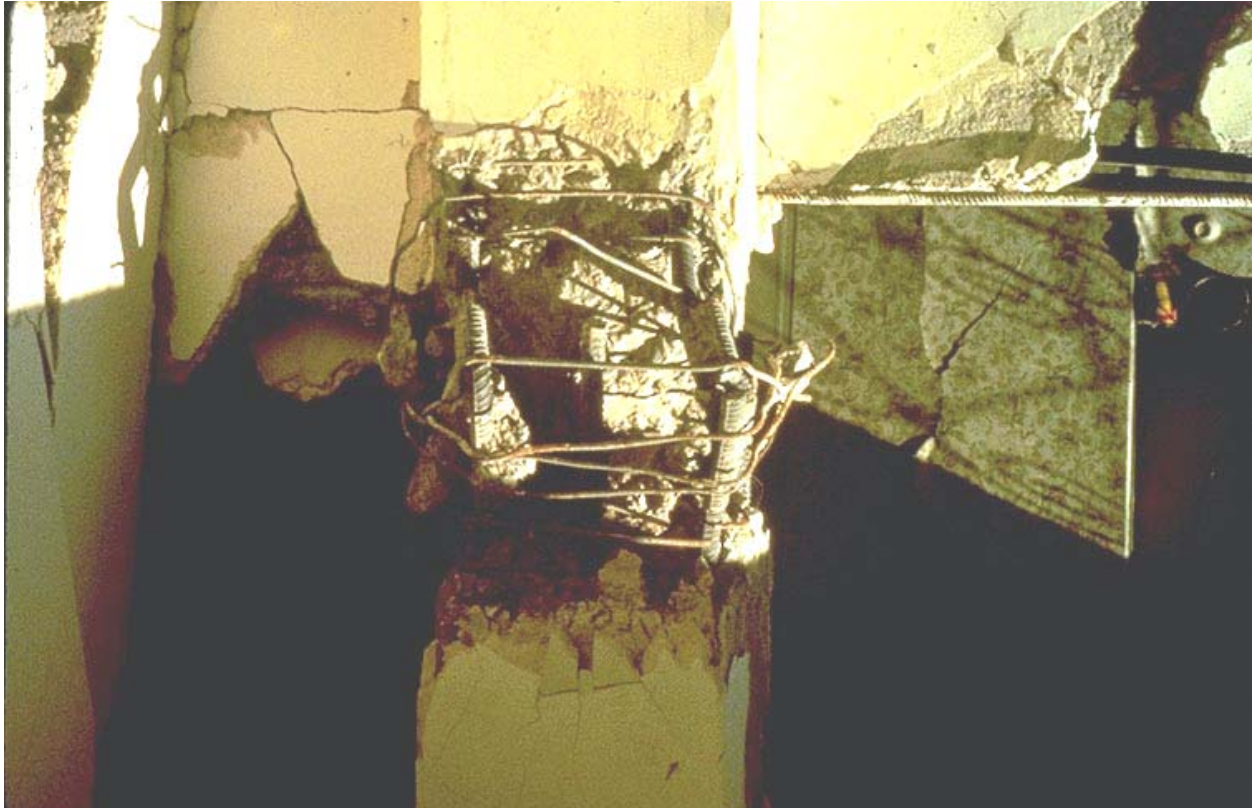
Brittle failure of welded rebar can be observed. Some rebar from the column above are not contained in the column below. This kind of failure at the connection between the precast column elements was very common.

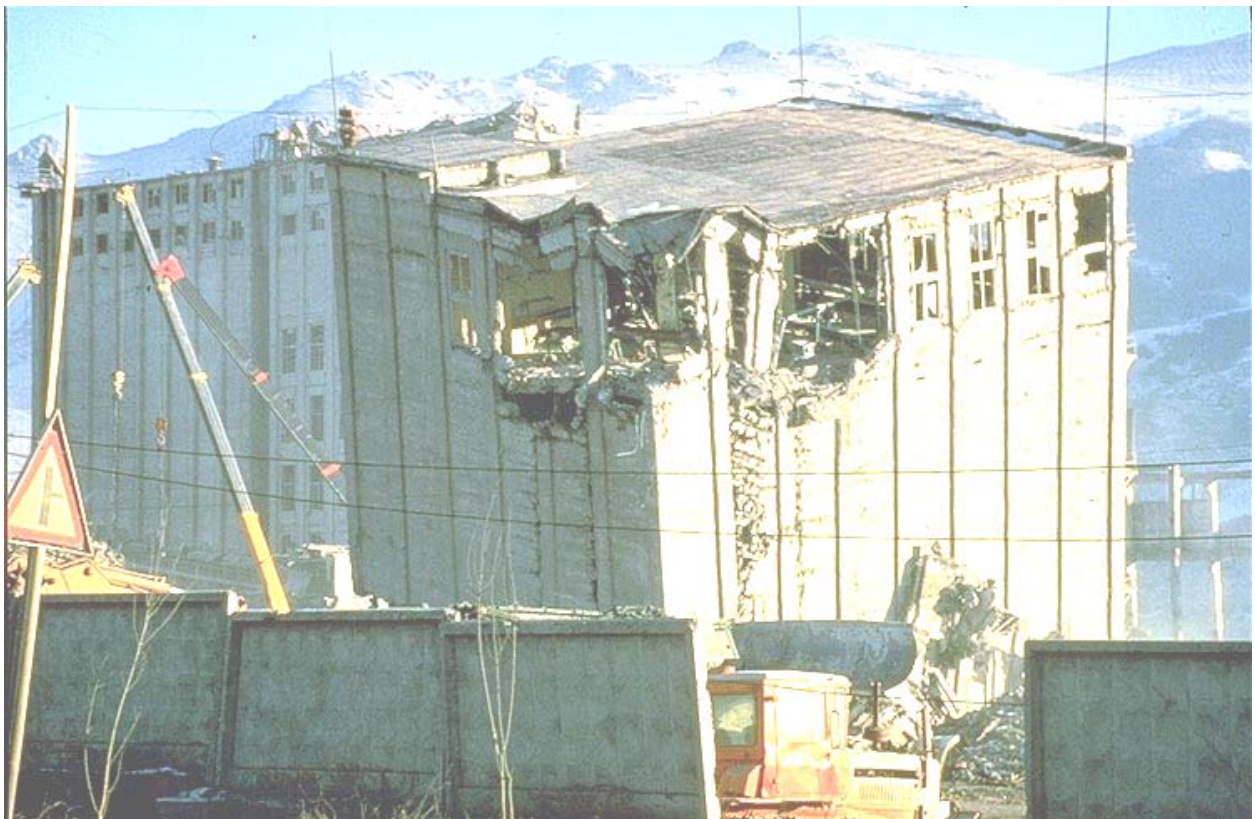
One of the collapsed cast-in-place and probably precast buildings of the granary. The building is at least the equivalent of a 10 to 15 story building. Collapse occurred in the third floor of the building which was a soft floor.

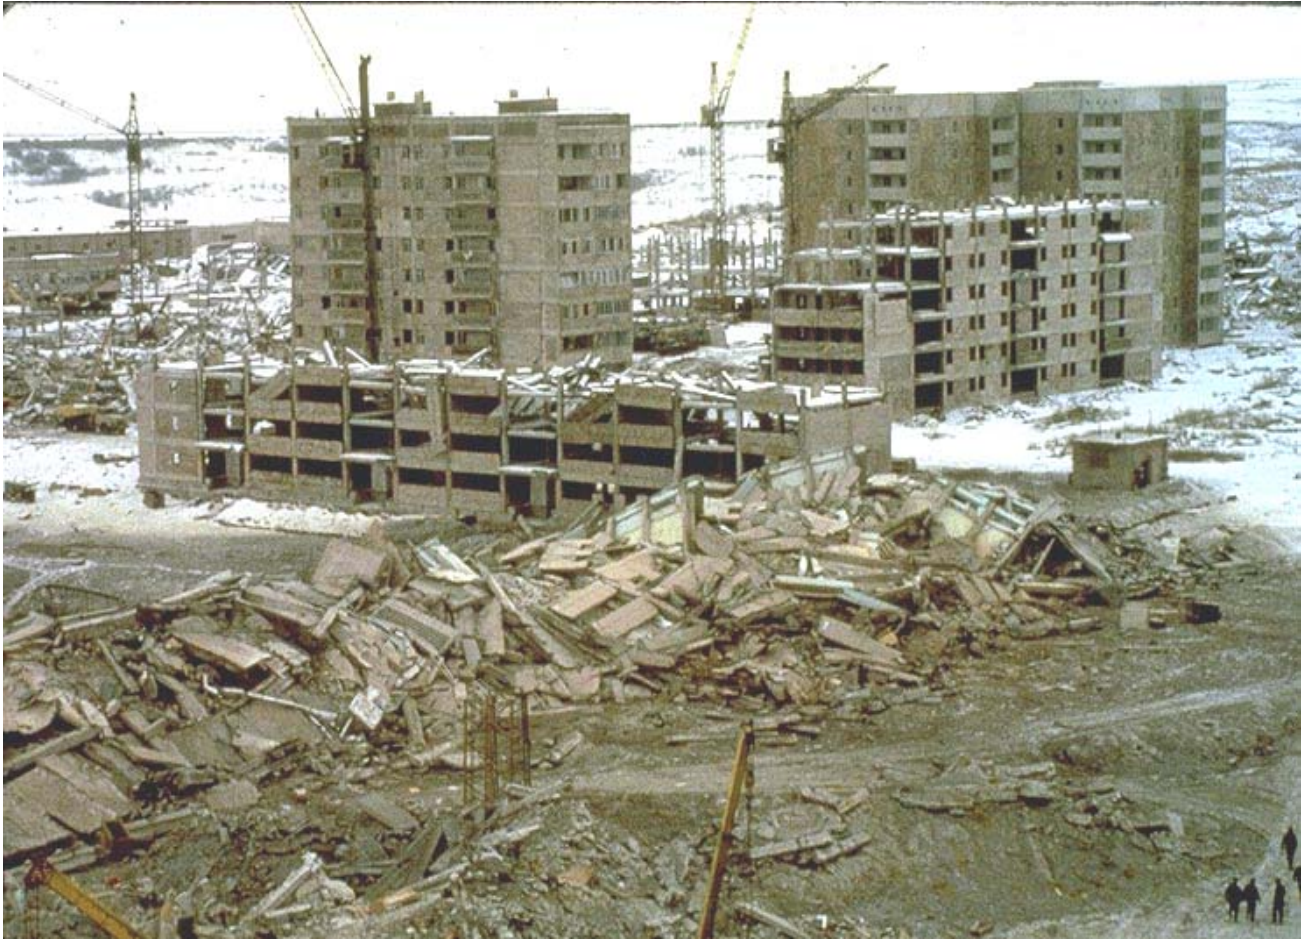
PRECAST CONCRETE PANEL BUILDINGS

In this photo, the performance of precast frame-panel and precast panel buildings can be compared. Many precast frame-panel buildings in Leninakan collapsed and are shown in the foreground, including one under construction.

Precast panel buildings, in contrast, performed very well and are shown standing in the background. The difference in performance is due to the basic differences in their design as well as possibly to specific characteristics of the ground motion. Site amplification in the 1.0 to 2.5 second band was found in the strong motion records of the aftershock sequence recorded in Leninakan may have generated a greater load on the concrete frame-panel buildings.

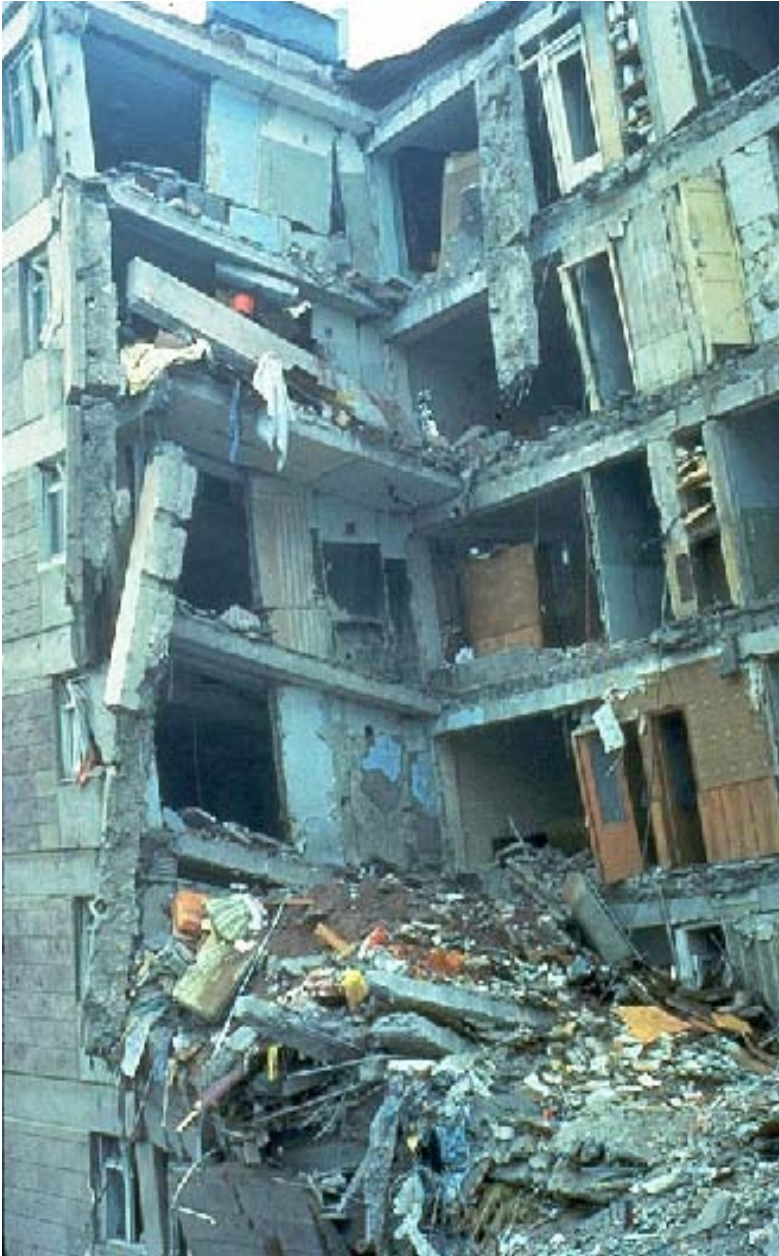
DAMAGE TO 9-STORY PRECAST CONCRETE FRAME-PANEL APARTMENT BUILDING IN LENINAKAN

This slide shows the type of building that performed poorly in Leninakan—the precast concrete frame-panel building constructed in the 1970's. Although this one is still standing in Leninakan, 54 percent of these buildings in Leninakan collapsed, 41 percent required demolition, 5 percent needed repair, and none of them escaped damage.

For example, deaths were 68 times and injuries rates more than 7 times higher in trapped than in nontrapped victims. This slide shows the failure of the building at the site fabricated joints. The precast floor planks contributed in a major way to the failure.

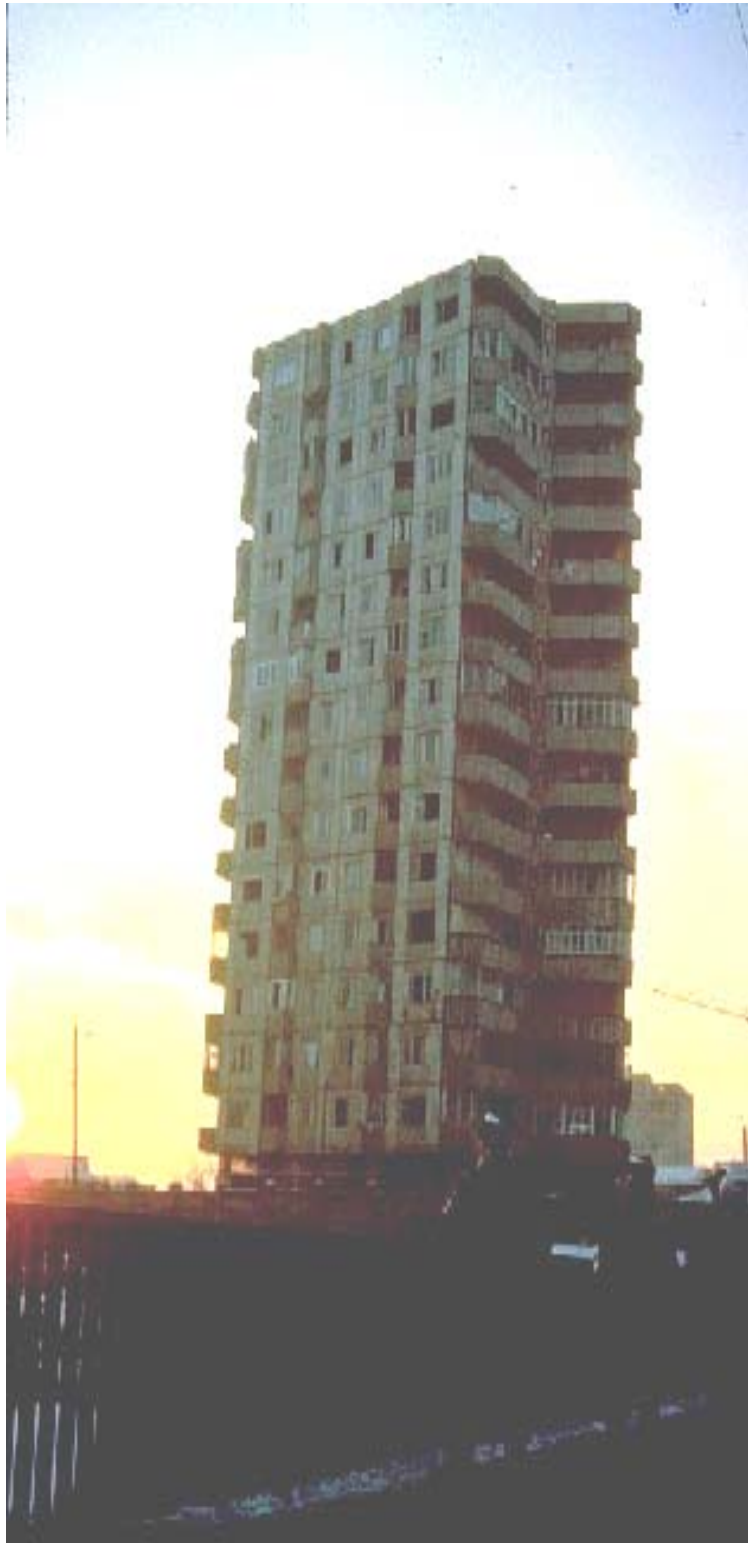
16-story lift-slab concrete building in Leninakan. The building is leaning about 1 meter to the right and is a total loss due to a general failure of the cast-in-place concrete shear core at the ground level.
